UNIVERSITY OF THE PELOPONNESE

DIPLOMA THESIS:

**Technological Study of mortars
from historic monuments in Greece.**

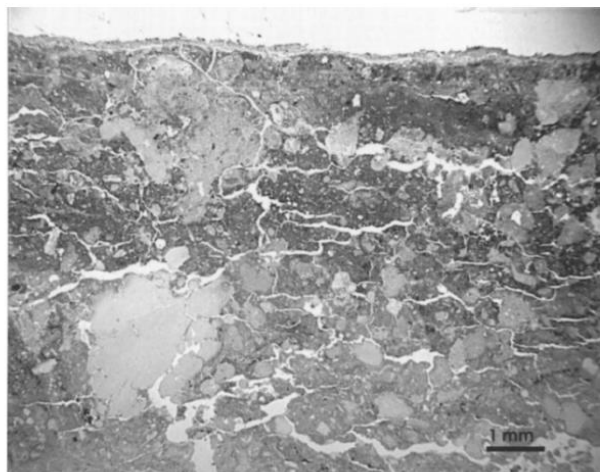
FIG. 3. Photomicrograph of a plastered floor with large quantities (30-40%) of lime inclusions and horizontal fissuring produced by compaction on the surface of the floor.

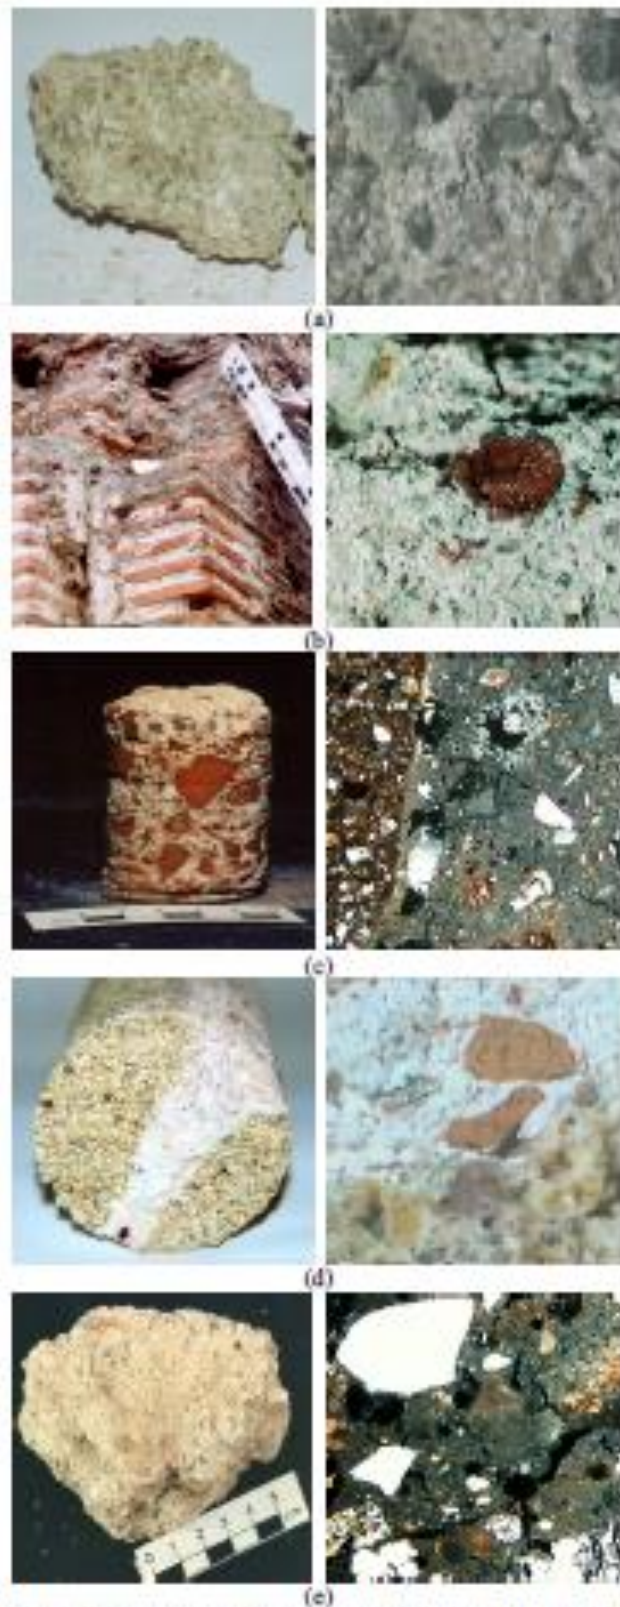
Fig. 1 Macroscopic and microscopic photos of structural mortars from various historic periods: (a) Hellenistic (Archaeological site of Lagras, 4th C BC); (b) Roman (Galerius Palace, 3rd C AD); (c) Byzantine (Saint Sophia, Thessaloniki, 8th C AD); (d) Ottoman (Bezestenli, 15th C AD); (e) Medieval (Medieval city of Rhodes, 15th C AD).

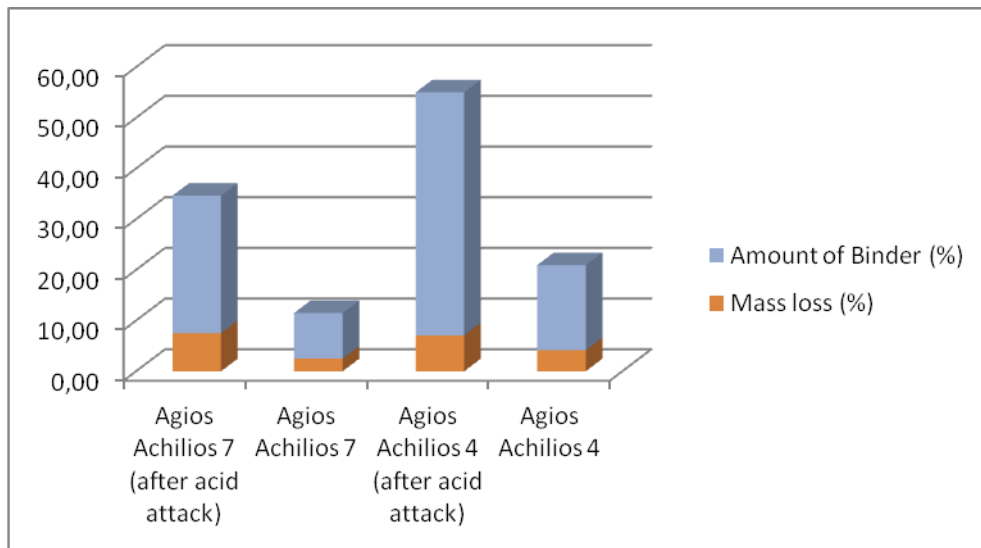
4 Influence of acid attack in binder and aggregate loss percentages

The influence of acid attack is best shown at the two following diagrams:

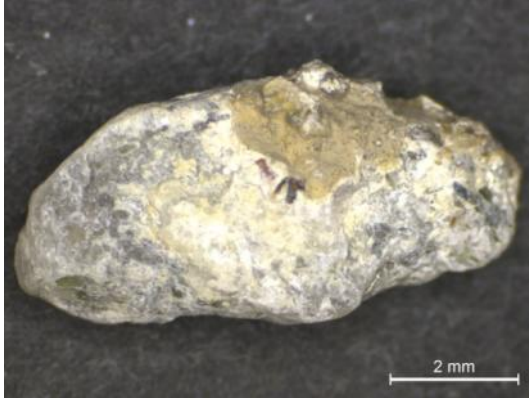
6 Agios Achillios 7, Grain retained in 4mm sieve

Grain still holding mortar in a cavity.

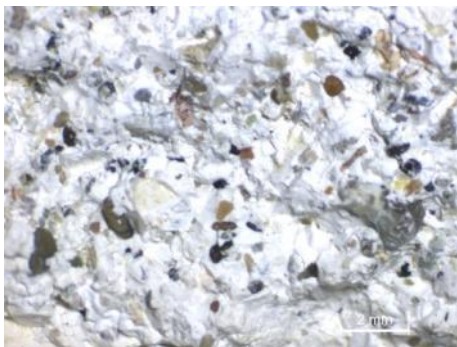
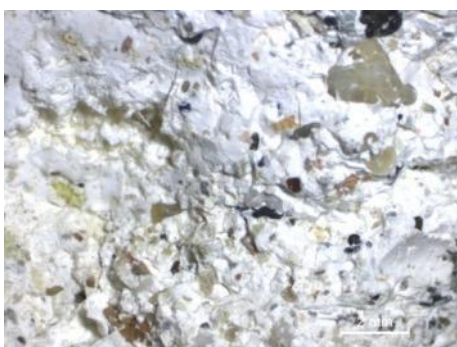
AG.AH._01

Bright white binder and extensive presence of ceramics as part of the aggregate matrix (AG.AH._01_02/3/4).

Smooth bright fractured surface (reflects like mirror). Dense aggregate matrix, grains in various sizes and angular shapes (AG.AH._01_04). One can also observe fractured aggregate grains, indicating good matrix-grain adhesion, a fissure network and the fracture surface following large aggregates network relief.

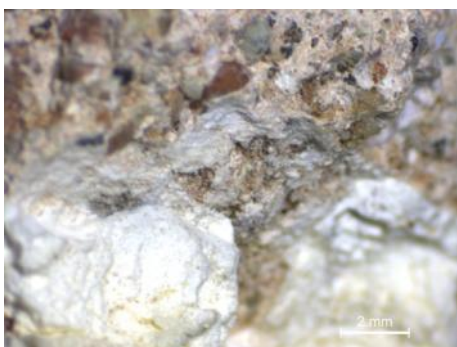
Fissure network more evident (AG.AH._02_03/4) and presence of bright white large regions (excess of lime?) (AG.AH._02_05/6)

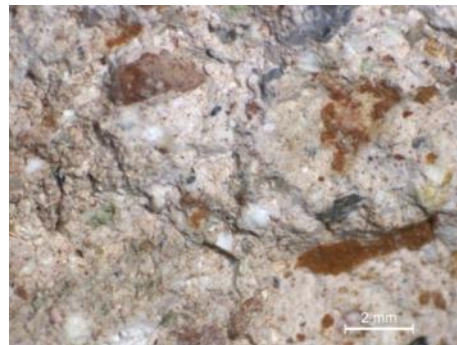
Regarding the rest aggregate grains, besides ceramics, light colored grains are dominant and most of them are not broken (AG.AH._04_02). On the contrary, most of the ceramics are broken and their boundaries are not clear (AG.AH._04_04).

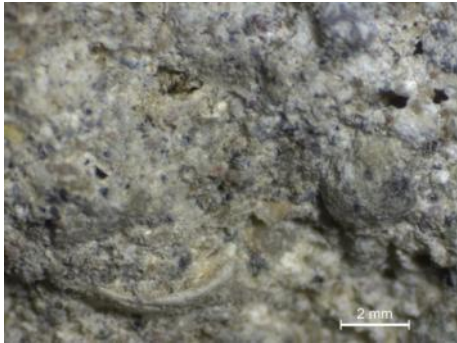
Absence of ceramics, white binder, rounded grains, presence of fissures and cracks. Compared to AG.AH._05 seems to have a coarser binder, more adhered to the grains. Compared to AG.AH.-02, possible more feeble.

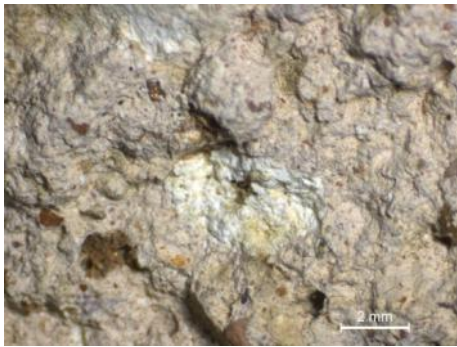
CPV-03

Presence of ceramics as part of the aggregate matrix (CPV_03_02) and possible ceramic powder in binder (see binder color in CPV_03_05). Bounders in ceramic aggregate grains are not clear (indications of chemical or alteration reactions in the interface). Small grains, maximum size of aggregates, around 0,3mm (CPV-03_03)
Network of fissures and cracks becoming visible (CPV_03_2/3).

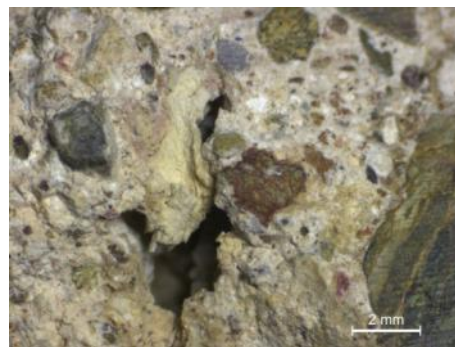
Cracks and void (F4_07 / 08)

Seems to have a compact matrix of aggregates, with a variety of grain size. Rounded larger grains, angular smaller dark ones.

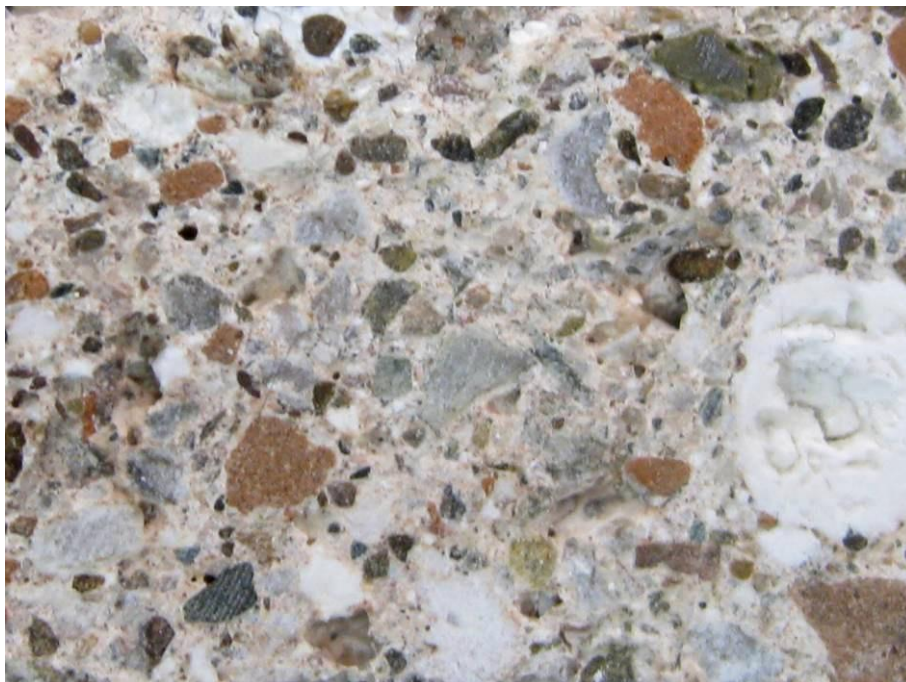
In all above pictures in stereoscope the microstructure can be observed: Solid structure of lime binder in mixture of ceramic powder, small presence of ceramics as aggregates along with natural light colored limestone grains and small presence of lime lumps.

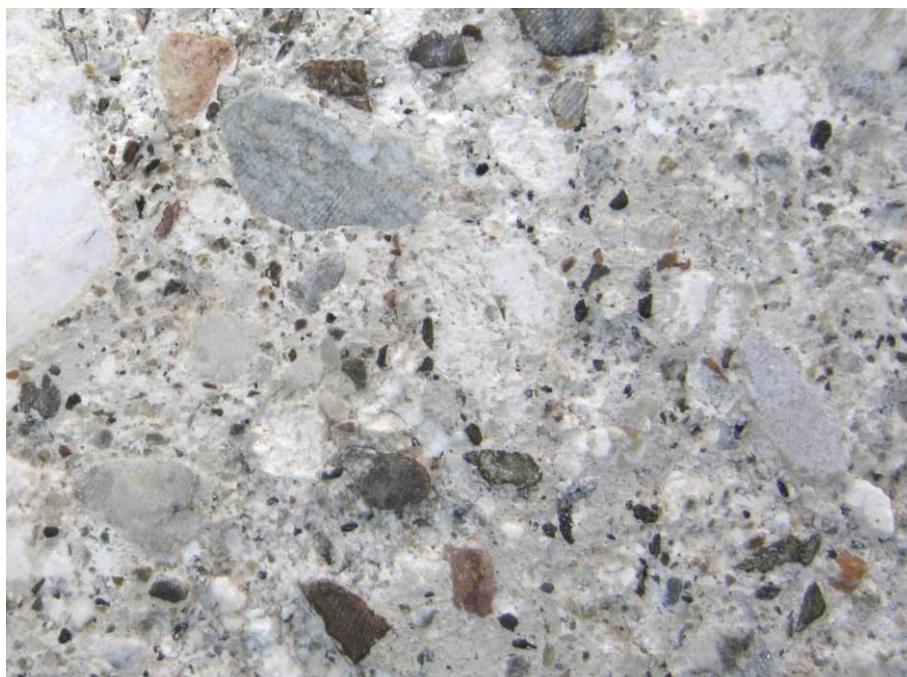
Mortar microstructure: cohesive structure and high percentage of well graded natural aggregates.

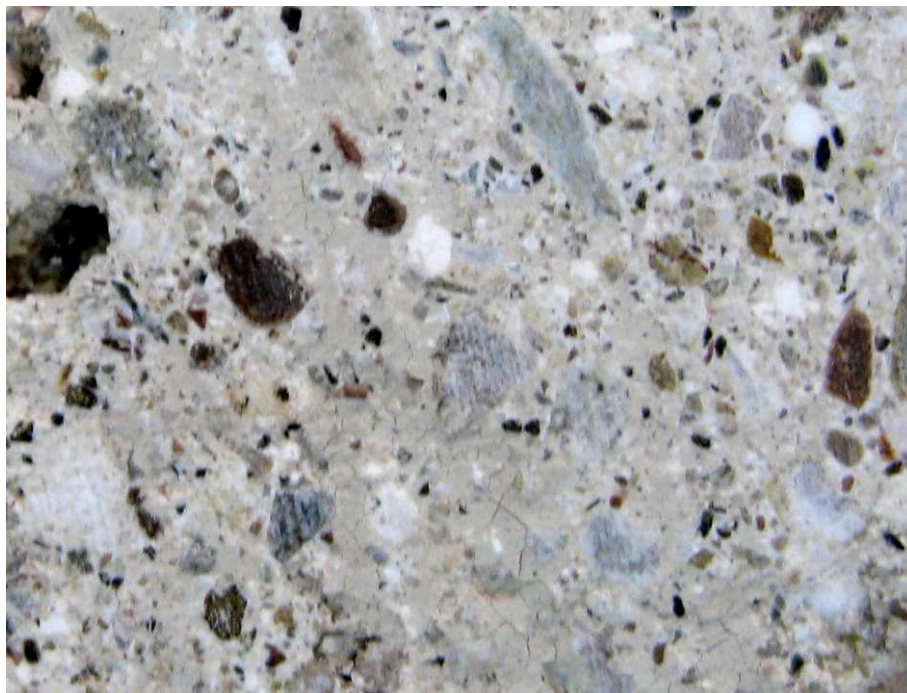
Strong presence of multi colored aggregates inside the cohesive structure of the mortar.

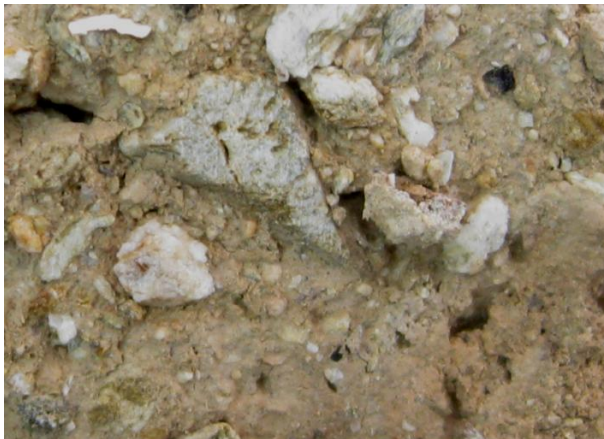
Loose mortar microstructure is observed along with the presence of natural aggregates and a lot of discontinuities and macro porosity. The result of the latter is the almost fully resin saturated samples observed in the last two pictures (samples prepared for SEM examination).

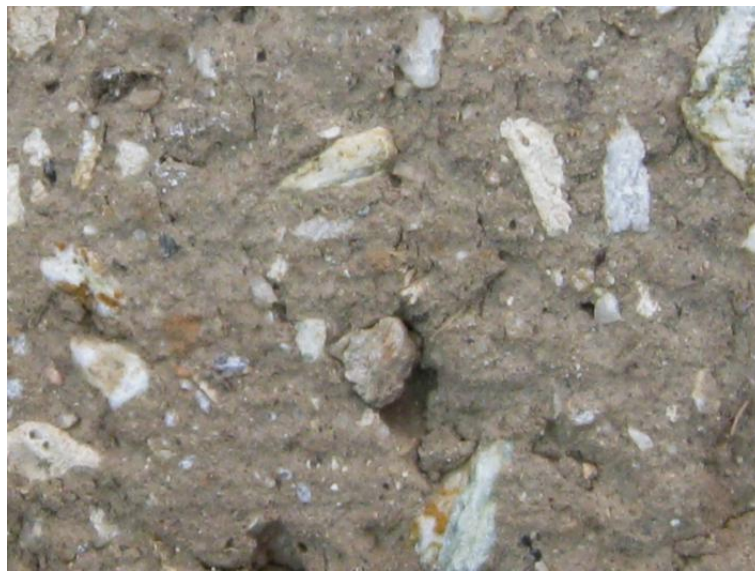
In above stereoscope pictures the loose microstructure can be observed along with natural aggregates and presence of micro cracking. In the last two pictures saturation of resin is also evident.

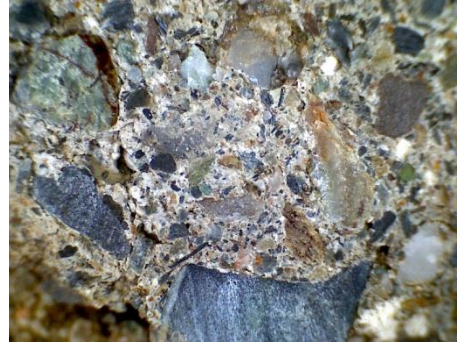
I.FOT.13 – Agia Larisas 2

Mortar microstructure in stereoscope (1st row): Loose microstructure with dense aggregate network and small fissures. In second row SEM samples are saturated in resin.

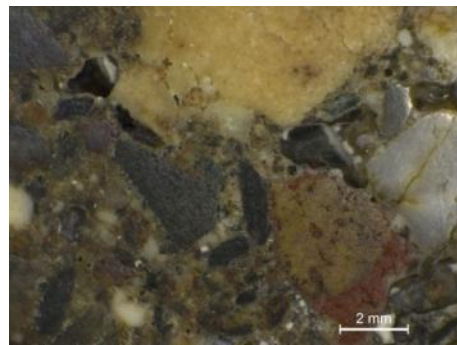
I.FOT.14 – Agia Larisas 9

Mortar microstructure in stereoscope:

1st raw: Relatively cohesive microstructure with macro porosity and small lime lumps.
